CASE HISTORY

Erosion Control and vegetation of artificial slope trenches along
S.P. Route 44 at Lentate, Milan and connecting road
to S.S. 35 "Dei Giovi", Italy

PRODUCT	TENAX TENWEB 3/300 geocells TENAX LBO 201 SAMP bi-oriented geogrids TENAX MULTIMAT 100 three- dimensional geomat
LOCATION	Lentate sul Seveso, Milan, ITALY, S.P. Route 44 at Lentate (Milan) and connecting road to S.S. 35 "Dei Giovi"
OWNER	Autostrada Serravalle S.p.A. - Milano - Ponte Chiasso
PROJECT	Dott. Ing. R. Formichi (Studio 3 Ingegneri Associati - MI)
CONTRACTOR	Verardi e C. S.r.L. (AL) and Peperelli S.r.L. (CO)

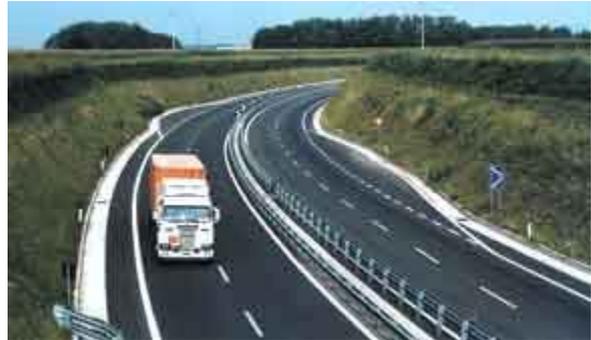
Overview of the S.P. 44 Road, few months after the end of construction

The total surface amounted to 50.000 m², with 22.000 m² of TENAX MULTIMAT 100 geomat, 2.500 m² of TENAX TENWEB 3/200 geocell and 25.000 m² of TENAX LBO 201 SAMP geogrid. After many months since the works were completed, no surface erosion or landslip was visible. The overall road structure blended into the local environment, due to the presence of the local shrubs that had been planted. The special technique used to prevent surface erosion allowed for relatively lower costs and high environmental performances.

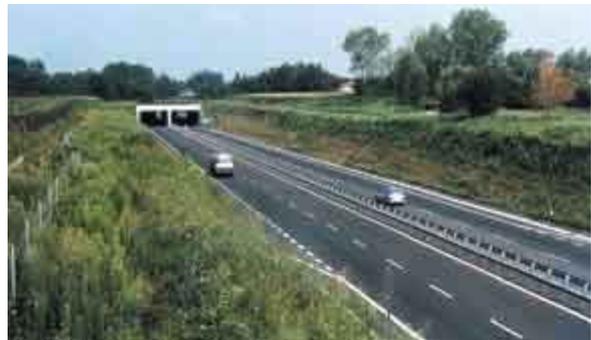
General view of the new S.P. 44 extension road, few months after project completion

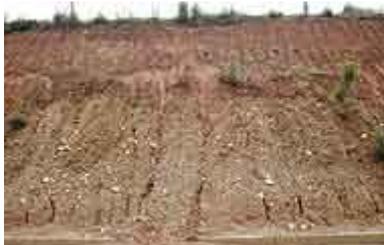
Detail of the extensive surface erosion

However, erosive forces on the surface layer undermined this stability and loss of soil cohesion. In the long term, the slope stability was going to be compromised starting from the cut face of the upper slope where run-off, superficial erosion and small soil sliding were more likely to happen. It was necessary to minimise the erosive effect of flowing water and enhance the shear resistance of the topsoil. It was also necessary to apply a suitable grass vegetation layer, hydro-seeding the slope with a mixture of seeds, organic material and fertilizers. In addition, eroded soil and pebbles were sliding down the cut slope to the road side. In order to find the best possible solutions for the erosion control, consolidation and vegetation of the slopes on the S.P. 44 at Lentate (Milan), the consultant was commissioned to give a geologic and agronomic solution. Geological and geotechnical investigations, geo-morphologic surveys and chemical testing applied to soil samples taken from different sections, determined 5 different typical section types. These were grouped according to height and inclination of the slope, to lithostratigraphic profiles, to water saturation persistence, to the main superficial erosion processes and to the fill soil characteristics both behind and surrounding the supporting concrete structures.

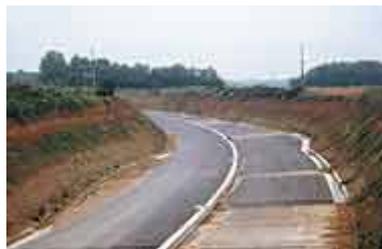
Slopes before anti-erosion treatment

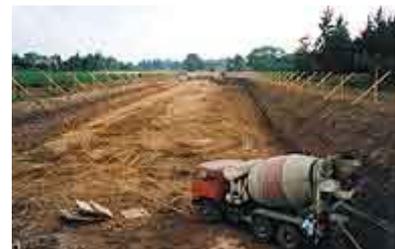
Roadbed and slope profile cutting and preparation

A drainage trench (1 x 0,50 m) was dug at the top of the slope to divert any surface water run-off from the cultivated fields adjacent to the site. The ground was then cleaned from debris, tree trunks, large stones and the slope smoothed and levelled. Below are the five different Section Types and their related technical solution is presented.

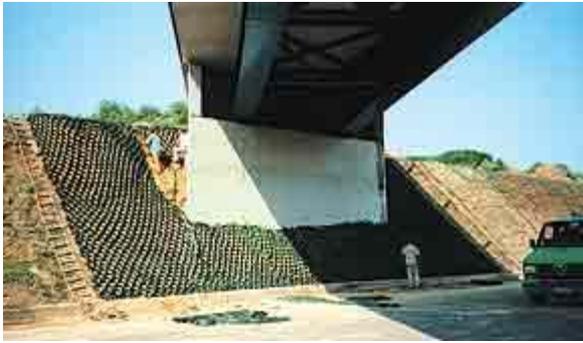
TENAX TENWEB geocells in place

The slopes close to the concrete structures were made up of imported fill material: loose granular soil with cobbles or fines. The high inclination and the low cohesion of the fill material indicated small landslips and rapid surface erosion with heavy soil transportation to the base of the slope could occur. Consolidation of this section was achieved using TENAX TENWEB 3/200 geocells (cell height 75 mm; cell inner diameter 200 mm), a honeycomb three-dimensional structure which provides an effective confinement for the imported vegetative soil placed in each single cell and thus preventing erosion by soil confinement. This product is made of polyethylene using a continuous extrusion process, it has a monolithic structure and is very resistant to tensile forces. TENAX TENWEB 3/200 was positioned opening the cells horizontally on the slope. It was then fixed to the top extending the geocells two metres beyond the crest and the cells secured with 1 m long anchors at the rate of one per square metre.

The cells were then filled with organic topsoil and the area was seeded with a mixture of grasses and deep rooting plants. To further decrease erosion, local shrubs (at least 0,6-1,0 m high) were planted within the cells at a rate of 1 shrub every 4 m².

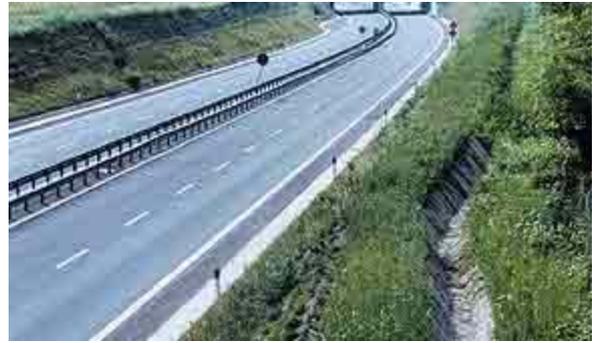
Zoom over the drainage trench on top of the slopes

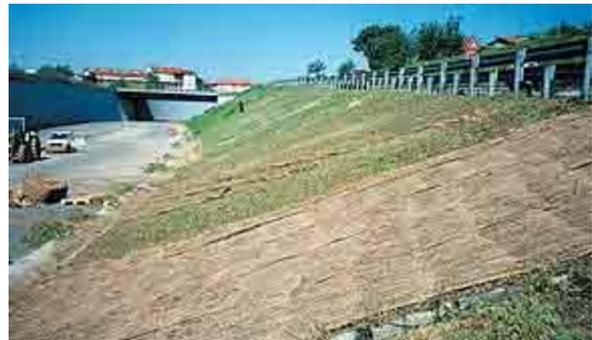
"Light" anti-erosion protection using a bio-degradable jute net

This section includes slopes 3 to 6 m high with an inclination below 40°, composed of soil deposits of rounded gravel (maximum size 100-120 mm) and sand. This section type included areas at the beginning of the road on the Milano-Como side, and some fill soil areas located by the concrete structures as the previous section type, but less steep. All existing weeds, since they couldn't guarantee soil consolidation, were cut and after levelling the slope were replaced with a seed mixture of grasses and deep rooting plants. A geojute anti-erosion biomes (mesh 20 x 20 mm; fixed with 2 pegs/m²) was installed to help prevent large cobbles sliding to the road and to promote healthy grass growth. The jute mesh was anchored to the soil extending it for 1 m over the crest.

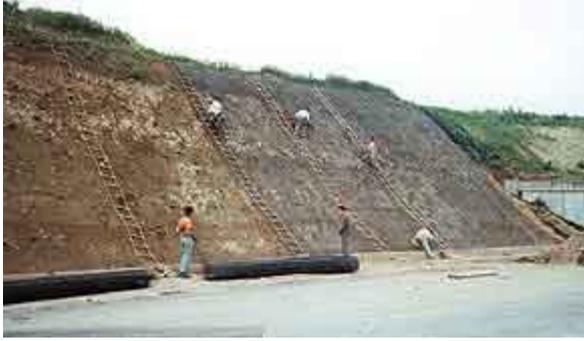
Installation of TENAX LBO 201 SAMP geogrids for cobbles containment

This section includes slopes less than 6 m high and with an inclination between 40° and 43°, with limited portions between 6 to 8 m high. The soil is composed of a deposit of rounded gravel with a superficial clay stratum in the first 2-3 m. In some stretches, there were lenses of very well compacted soil at the bottom of the slope. On the existing cut slope, it was necessary to level the slope and remove unstable cobbles. Slope reinforcement and stone containment was achieved using TENAX LBO 201 SAMP geogrid. This is a polypropylene geogrid especially designed for soil stabilization and manufactured from a unique process of extrusion and biaxial orientation to enhance its tensile properties. The geogrid was fixed with 400 mm metal pegs; 1 peg/m² and covered with 25 mm of topsoil. The area was hydro-seeded with a mixture of grasses and deep rooting plants, inserting also local shrubs. Where possible, the same procedure was used also for extending the geogrid 2 m behind the crest.

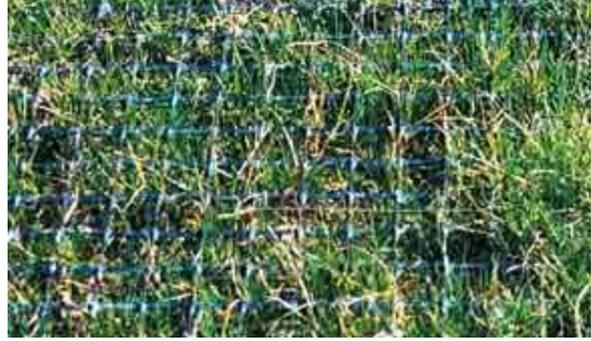
Details of the vegetated TENAX LBO 201 SAMP geogrids

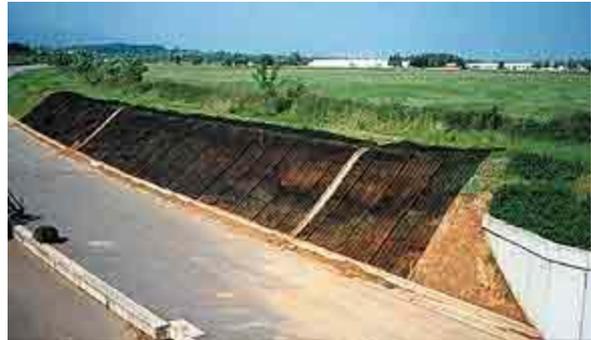
"Heavy" anti- erosion protection using TENAX MULTIMAT 100 geomat

Section type 4 includes slopes 7 to 10 m high and with a maximum inclination up to 45°. On the upper part, red compacted scaly clay layers could be found in horizontal lenses. Along these layers capillary water could occur diminishing stability and leading eventually to superficial detachment and face sloughing up to 200 mm deep. The lower portion of the slope was mainly composed of gravel and pebbles with a sand matrix. Soil was consolidated using TENAX MULTIMAT 100.

These are polypropylene erosion control geomats, designed for protection and grass growth on slopes subject to surface erosion. TENAX MULTIMAT 100 are three dimensional mats composed of extruded and bi-oriented polypropylene grids, laid one upon each another and tied up by means of a black polypropylene yarn.

The three dimensional structure of the mat shelters the layer of top soil and anchors the growing roots of the planted seeds, obtaining a reinforced block very resistant to rain run off and soil movement. The area was hydro seeded with a water mixture of grasses and deep-rooted plants (30-40 g/m²), emulsion, organic fertilizers (100 g/m²) and organic soil (peat, compost and cellulose 30% weight). To further decrease erosion, local shrubs were planted.

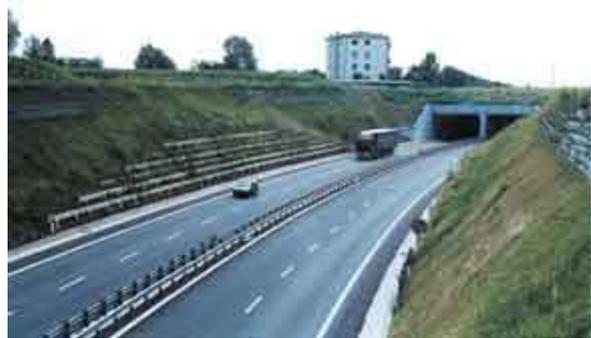
Slope consolidation using TENAX MULTIMAT 100 and prefabricated walls

This section type includes slopes more than 8 m of height with inclination in excess of 45°. A clay layer, 4 m thick, was present with clear signs of superficial erosion due to persistent water saturation. Along these layers, capillary water could rise diminishing stability and leading eventually to superficial detachment and face sloughing up to 200 mm deep.

Two techniques were used to consolidate the slope: TENAX MULTIMAT 100, as described in the previous Section Type 4, and the construction of a concrete prefabricated modular wall back filled with an appropriate granular free-draining soil.
